# LESSONS LEARNED / BEST PRACTICE

<b>Year_No.</b>	2018_01
<b>Title:</b>	On a day in August 2018, an Irish Contractor experienced a near miss that could easily have resulted in a workplace fatality.
<b>What Happened / Impact?</b>	<b>Photo / Sketches</b>
<p><b>Task in hand:</b> Laying a 180mm OD HDPE pipe through an urban area – a daily activity for the Contractor.</p> <p><b>In line with safe systems of work –</b></p> <ul style="list-style-type: none"> <li>• The relevant utility companies were contacted in advance of the works and the relevant utility drawings received.</li> <li>• The Site Team did not take the utility drawings for granted and had their SOLAS LUGS (Location of Underground Services) team member scan the ground using a CAT 4 PLUS. Additional underground services were encountered, and the ground was subsequently marked appropriately, indicating the location of the known and newly located services.</li> <li>• A Permit-to Dig was completed.</li> <li>• Relevant location and signed by relevant personnel.</li> <li>• A RAMS was in place and signed off by relevant personnel.</li> <li>• An SPA (Safe Plan of Action) that included the underground services were completed and brie

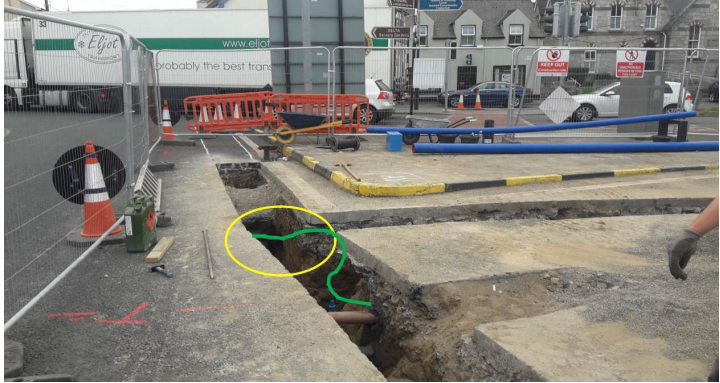
<p><b>**Green line: Redundant cable ‘snaking’ through trench. Yellow circle: ESB Duct</b></p>

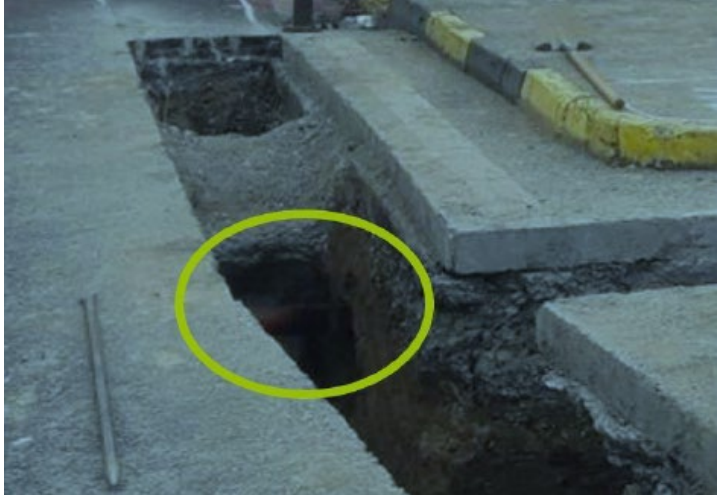
<p><b>**ESB Duct crossing trench</b></p>

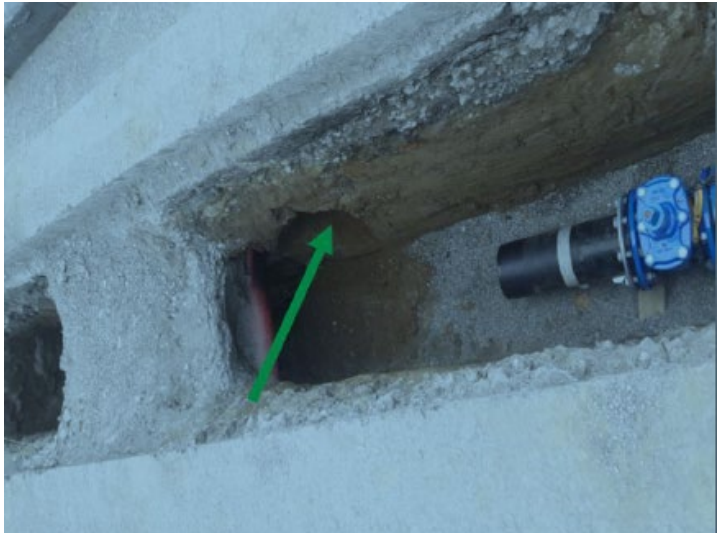
<p><b>**Line of redundant cable crossing ESB Duct.</b></p>

- The site had encountered a known and confirmed redundant 50mm copper cable at various stages along the pipeline. The troublesome section of the redundant cable had been cut out using a consaw.
- Being aware of the services and the services being visible, in an effort to ‘get the job done’, GO proceeded to cut the redundant cable. A small quantity of earth obscured the GO’s sight of the ESB duct and as pressure was exerted on the 50mm cable, the ESB duct was cut. Unfortunately, the duct contained 3nr. Cables resulting in the 10KVa cable resting flush to the internal wall of the duct. The 10KVa cable was cut.

- Thankfully no-one was injured in this incident as the centre aluminium conductor was not cut, but we should use this as a reminder that with all the necessary systems in place, our safety and that of our colleagues relies on our awareness of safety, our attitude to safety and our actions.
- PLEASE - STOP. THINK. ACT.
- NOTHING is more important than ensuring that everyone goes home safely every day.
