| <b>Title:</b> | <b>2026/20 – Kelly Block Failure</b> |

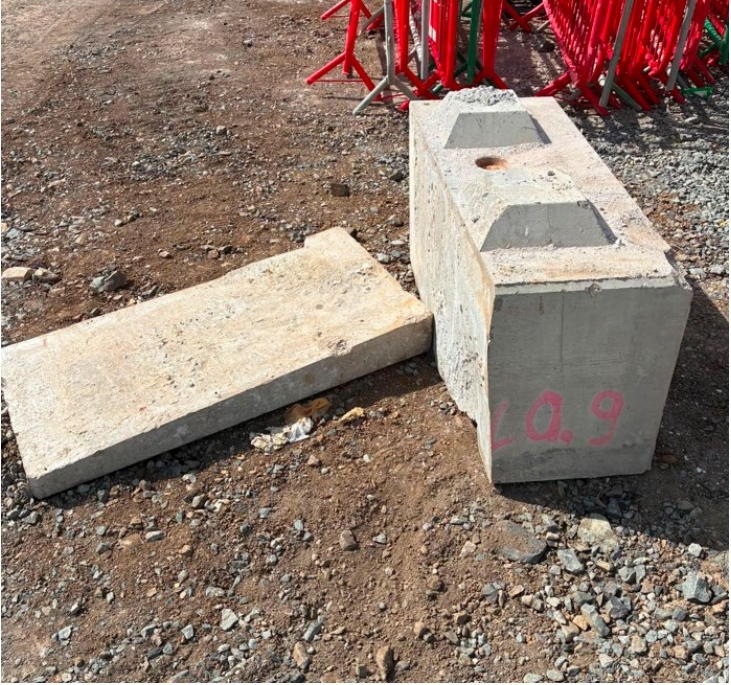
| <ul style="list-style-type: none"> <li>Following a lift movement, a section of an interlocking concrete Kelly Block detached and sheared off after the block had been landed on the ground.</li> <li>Thankfully, no-one was injured, though the contractor has initiated a near miss investigation.</li> <li>Kelly Block are large precast concrete blocks, with standard/full blocks weighing between 1 and 1.6 tonnes.</li> <li>These blocks may be used for a wide variety of applications in construction.</li> <li>Whilst the investigation is ongoing, the contractor wishes to share this near miss event with the wider industry to raise awareness and help prevent similar occurrences.</li> </ul> | |
| <ul style="list-style-type: none"> <li>The contractor using the Kelly Blocks has engaged the manufacturer and supplier of the Kelly Blocks and requested a full incident investigation, including a review of the block design, manufacturing process and all relevant documentation.</li> <li>Preliminary findings from the contractor's investigation suggest that the Kelly Block may have been cast in two separate pours, with the failure occurring along a potential cold joint between the sections, resulting in the block shearing at this interface.</li> </ul> | |

| <ul style="list-style-type: none"> <li>The contractor has implemented an immediate suspension on all lifting operations involving these Kelly Blocks pending the outcome of the investigation.</li> <li>The contractor also intends to progressively remove and destroy the affected Kelly Blocks as a precautionary measure.</li> <li>Kelly Blocks that appear to have been cast in two sections should not be lifted without the manufacturer having supplied a specific design for this arrangement confirming its safety and adequacy - including the safe method of lifting the Kelly Block using any cast in lifting anchor / device.</li> <li>This lesson learned has been shared with the CIF to raise awareness of the potential risks associated with these blocks and to help prevent similar incidents or accidents occurring in the future.</li> </ul> | |
