LESSONS LEARNED / BEST PRACTICE

2019/03 - Stone Between Truck's Dual Tyres Became Dislodged

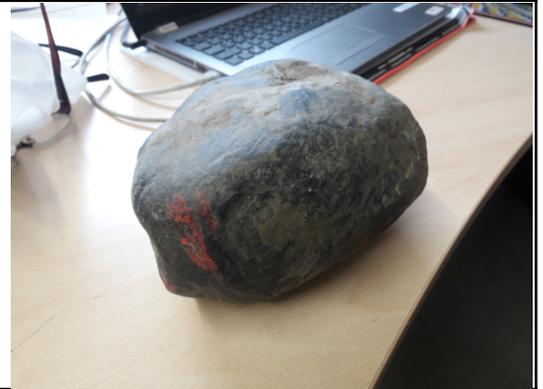
A large stone (pictured) stuck between the dual tyres of a truck engaged in site clearance works became dislodged as the truck gathered speed and was catapulted from the rear wheels. The stone travelled across a road and foot path and came to rest when it hit a hoarding of a nearby site.

- Hard-standing was unsuitable for the trucks being loaded in that it was not suitably blinded off.
- Trucks leaving the site were not subject to visual checks to confirm the absence of materials/stone between the dual tyres.

- It can be difficult to identify rocks stuck between dual/double tyres, particularly on the inner axle.
- A suitable haul road should be installed with a blinded surface to prevent large stones encountering the truck wheels.
- All trucks to be checked for lodged stones prior to leaving site if there is a risk of the wheels coming into contact with same.
- A safe system of work needs to be in place to remove stones that become lodged in the space between dual tyres. A system that uses downward force only is preferred as it eliminates the risk of the stone becoming a projectile during the removal operation.
- A crowbar used correctly is a viable tool for stone removal.
- The use of a proprietary device on the quick-hitch of an excavator may be used to remove lodged stones.

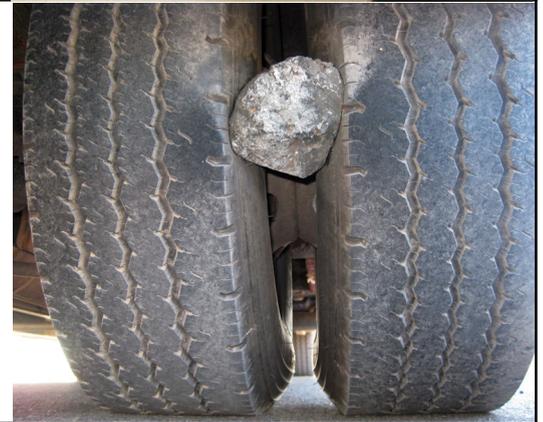
The rock would have been stuck between the tyres, as illustrated.
