# LESSONS LEARNED / BEST PRACTICE

<b>Title:</b>	<b>2021-01 - Edge Protection on Pick-up Truck</b>
<b>What Happened / Impact?</b>	
<p>While loading pedestrian barriers onto a pick-up truck, the injured party moved back towards the side of the pick-up.</p> <p>He then lost his balance and fell backwards over the rail, landing on the ground, sustaining injuries to his back and shoulders.</p> <p>The photograph provided is for illustrative purposes.</p>

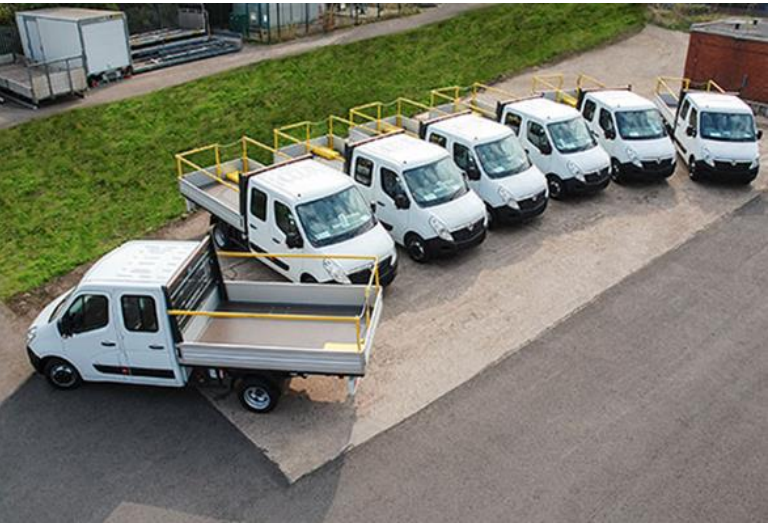
<b>Why it Happened?</b>	
<p>Pick-up trucks provided by the Company are fitted with edge protection, as illustrated.</p> <p>On the day of the incident, a company vehicle was recalled for service and a replacement (hired) vehicle was used.</p> <p>The replacement vehicle did not have edge protection around the bed of the pick-up and thus did not provide fall protection.</p>

<b>Immediate Learnings / Recommendations</b>	
<ol style="list-style-type: none"> <li>1. Ensure that the company's policies and procedures are adhered to when replacement vehicles are sourced externally.</li> <li>2. Contact all vehicle rental companies with whom the company contracts for the supply of temporary vehicles, advising of the requirement for edge protection where there is a risk of injury to the vehicle user.</li> <li>3. Ensure that all senior staff and supervisors are aware of the company's requirements for edge protection on vehicles where there is a risk of falls from height and that personnel should not proceed if the edge protection is not in place.</li> </ol>
