# LESSONS LEARNED / BEST PRACTICE

<b>Year_No.</b>	2018_01
<b>Title:</b>	On a day in August 2018, an Irish Contractor experienced a near miss that could easily have resulted in a workplace fatality.
<b>What Happened / Impact?</b>	<b>Photo / Sketches</b>
<p><b>Task in hand:</b> Laying a 180mm OD HDPE pipe through an urban area – a daily activity for the Contractor.</p> <p><b>In line with safe systems of work –</b></p> <ul style="list-style-type: none"> <li>• The relevant utility companies were contacted in advance of the works and the relevant utility drawings received.</li> <li>• The Site Team did not take the utility drawings for granted and had their SOLAS LUGS (Location of Underground Services) team member scan the ground using a CAT 4 PLUS. Additional underground services were encountered, and the ground was subsequently marked appropriately, indicating the location of the known and newly located services.</li> <li>• A Permit-to Dig was completed.</li> <li>• Relevant location and signed by relevant personnel.</li> <li>• A RAMS was in place and signed off by relevant personnel.</li> <li>• An SPA (Safe Plan of Action) that included the underground services were completed and brie

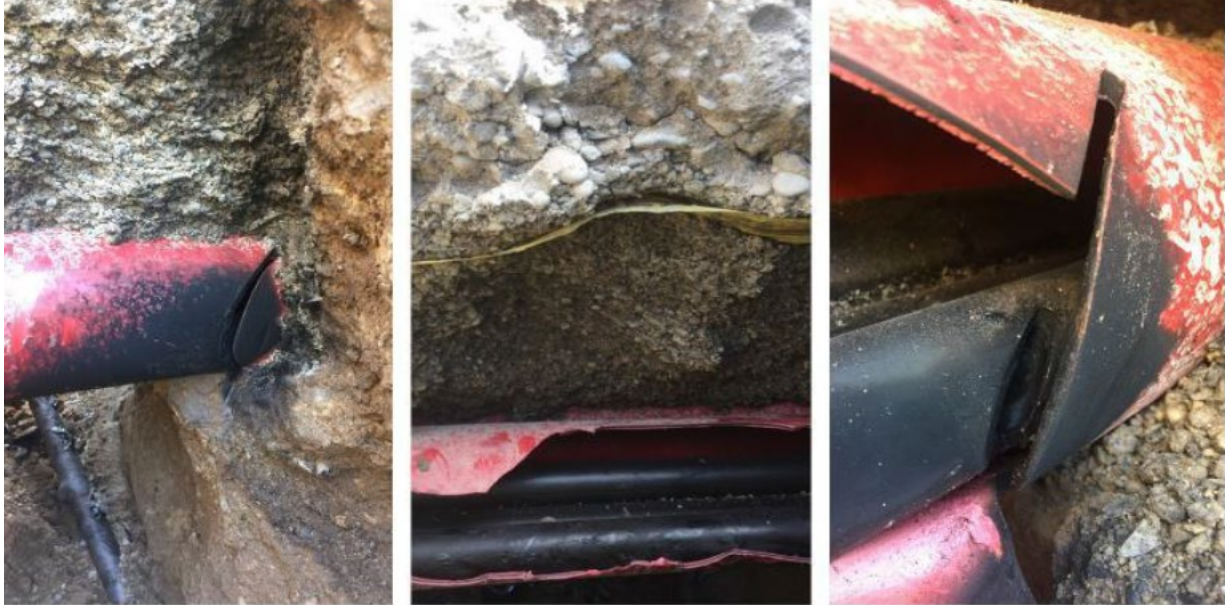
- The site had encountered a known and confirmed redundant 50mm copper cable at various stages along the pipeline. The troublesome section of the redundant cable had been cut out using a consaw.
- Being aware of the services and the services being visible, in an effort to ‘get the job done’, GO proceeded to cut the redundant cable. A small quantity of earth obscured the GO’s sight of the ESB duct and as pressure was exerted on the 50mm cable, the ESB duct was cut. Unfortunately, the duct contained 3nr. Cables resulting in the 10KVa cable resting flush to the internal wall of the duct. The 10KVa cable was cut.

- Thankfully no-one was injured in this incident as the centre aluminium conductor was not cut, but we should use this as a reminder that with all the necessary systems in place, our safety and that of our colleagues relies on our awareness of safety, our attitude to safety and our actions.
- PLEASE - STOP. THINK. ACT.
- NOTHING is more important than ensuring that everyone goes home safely every day.
