LESSONS LEARNED / BEST PRACTICE

Title:	2021/04 – Finger Injury with Concrete Chute
What Happened / Impact?	
<p>Injured person sustained a broken finger when impacted by a folding concrete chute.</p>

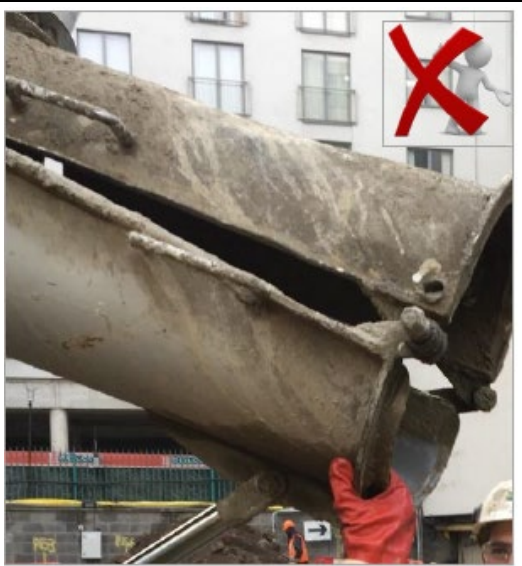
Why it Happened?	
<ul style="list-style-type: none"> • Operative A was performing the role of spotter while a concrete lorry was reversing. • Operative A pulled the lorry’s chute into position, the end of the folded chute. • Not realising Operative A had his hand on the end of the chute, his colleague (Operative B), flipped-over the extension piece of the chute, catching the finger of Operative A between the 2 folding sections. • This resulted in Operative A breaking his index finger. • Operative A was not using the handles on the chute and there was a lack of communication between Operatives A and B. 	
Immediate Learnings / Recommendations	
<ol style="list-style-type: none"> 1. The concrete pump operator is responsible for operating equipment. 2. Operatives must follow the directions of the pump operator if assisting. 3. Operative must use the handles provided to manoeuvre the concrete chute.
